COMMISSION FOR HISTORICAL & ARCHITECTURAL PRESERVATION

STAFF REPORT

REQUEST: Alterations to Rear Elevation and Construct Garage

ADDRESS: 1209 North Calvert Street (Mount Vernon Historic District)

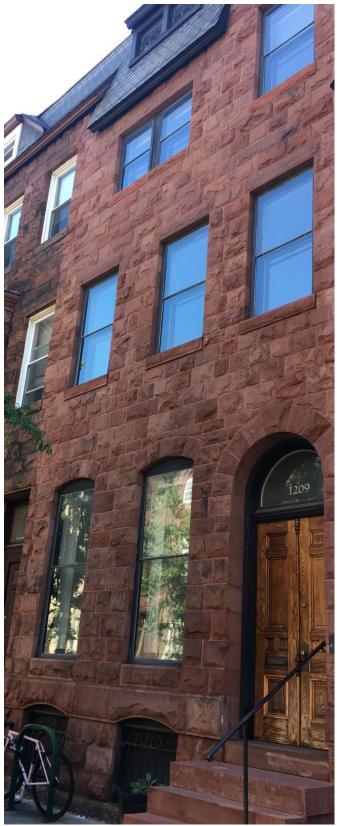
Image 2- Front Elevation of 1209 N. Calvert Street

<u>Site Conditions/Architectural Description:</u> The four-story brownstone rowhouse features an arched door surround on the first floor, and paired windows in a shed dormer at the fourth floor. The rear of the building is composed of a bay that includes the historic chimney and culminates in the three ornamental bishop's cap details. An early first floor addition extends from the northern most opening at and was likely constructed to house a new kitchen in the 1900s.

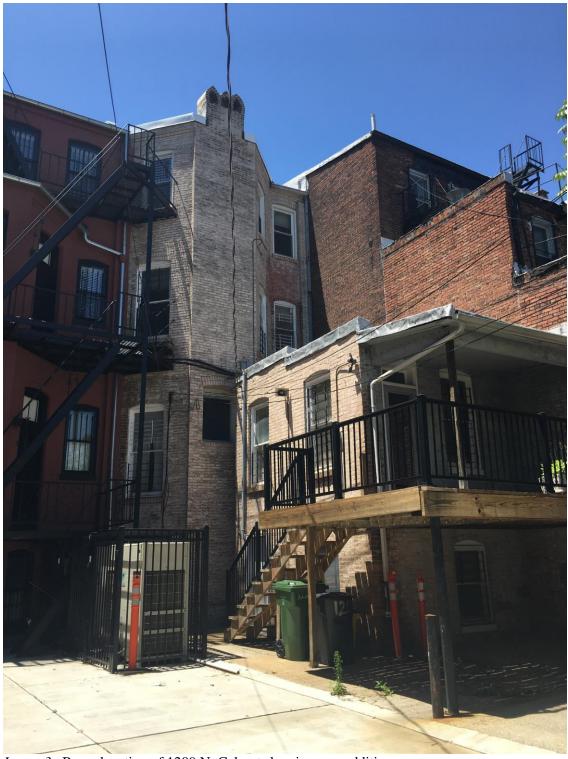
Image 3– Rear elevation of 1209 N. Calvert showing rear addition.

This guideline also states, "Avoid demolishing historic building, structures, and landscapes when designing new construction projects." The proposed demolition of the rear addition, dating to the early 1900s, does not meet this guideline. The basement level of the addition is not to code at roughly 7'-0" in height and the property owner intends to return the first floor to its historic appearance with a window flanking the chimney and an exterior door. These unique circumstances, as well as the alterations to the addition and it location on the rear of the building make its demolition acceptable.

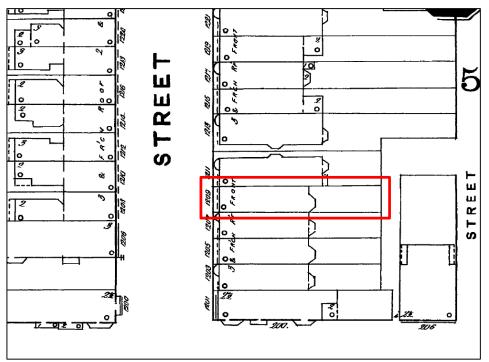
Image 4–1890 Sanborn Map showing original foot print of historic building at 1209 N. Calvert Street.

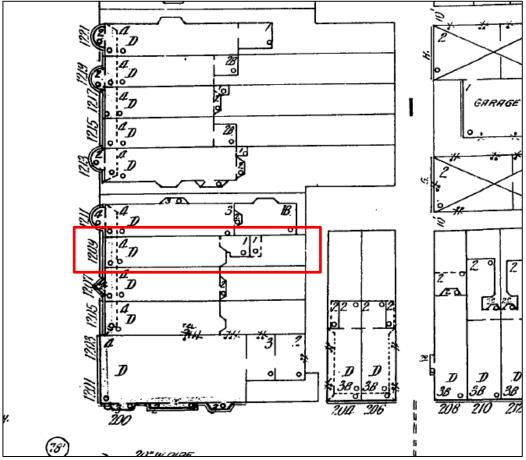
Image 5–1914 Sanborn Map showing rear addition at 1209 N. Calvert Street.

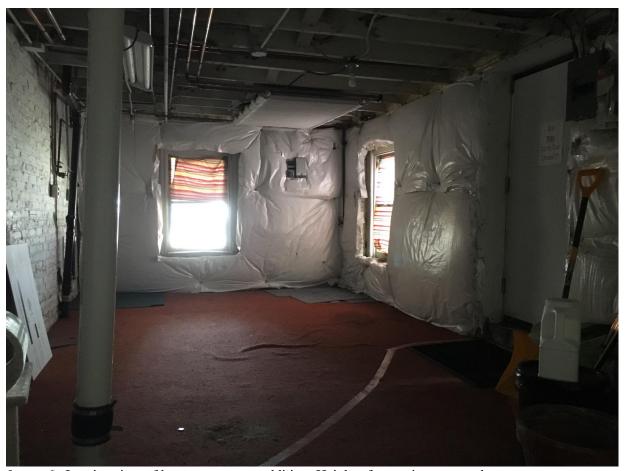
Image 6– Interior view of basement at rear addition. Height of space is not to code.

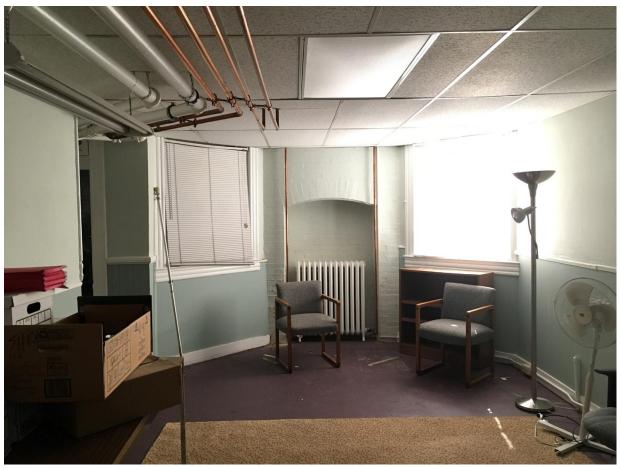
Image 7– Interior view of basement at rear wall. Applicant proposes the removal of the two walls flanking the historic fireplace and chimney.

1.18 – Alterations and Additions which states the following, "Design alterations and additions to be compatible and sympathetic to the character of the historic building." The alteration at the basement that includes the removal of most of the masonry wall does not quite meet this guideline, however as the location of the alteration is so secluded and the design is compatible, if modern, the alteration somewhat meets this guideline.

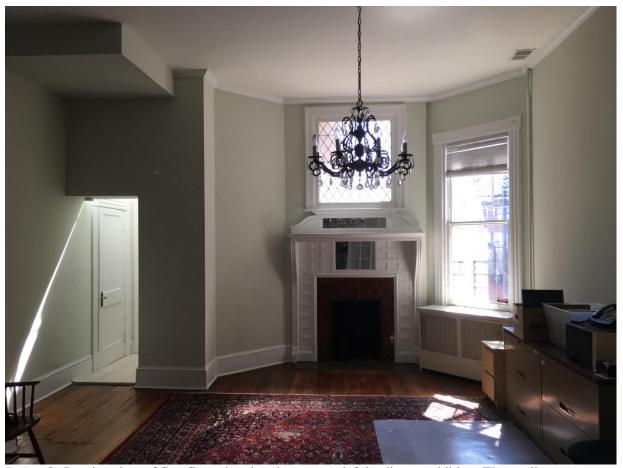
Image 8– Interior view of first floor showing doorway at left leading to addition. The applicant proposes to reveal or reinstall the window to the left of the fireplace and an exterior door.

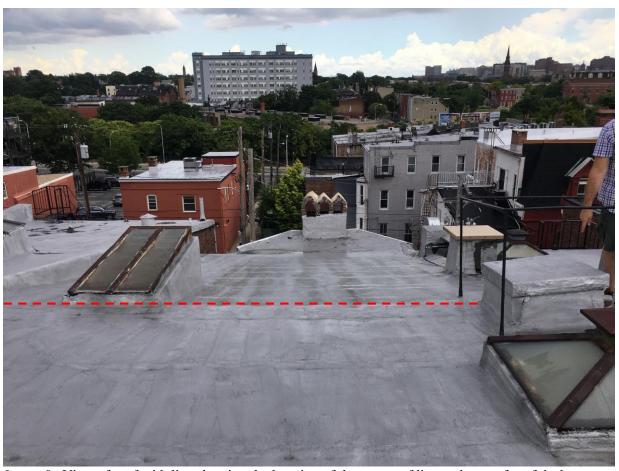
Image 9– View of roof with line showing the location of the new roof line and start of roof deck.

1.8.10 - Roof Decks states "New roof decks must not be visible from the street-front grade along any primary elevation. Locate roof decks at the rear of a building whenever possible to minimize visibility." The proposal is unique as the applicant intends to remove an inaccessible portion of the fourth floor attic space and insert a deck beyond the brick wall at that level. The result is a hidden deck that is easily accessed from the front of the fourth floor, but largely invisible. Drainage at the proposed new roof deck will be key to this proposal, as the removal of a historic roof typically causes problems for property owners.
